**WOOD-DESTROYING ORGANISMS INSPECTION REPORT**  
 Section 482.226, Florida Statutes and Chapter 5E-14.142, F.A.C.

Address of Property Inspected: **9830 Cornell Avenue, Tampa, FL 33602**

Structures on Property Inspected: **House with attached garage**

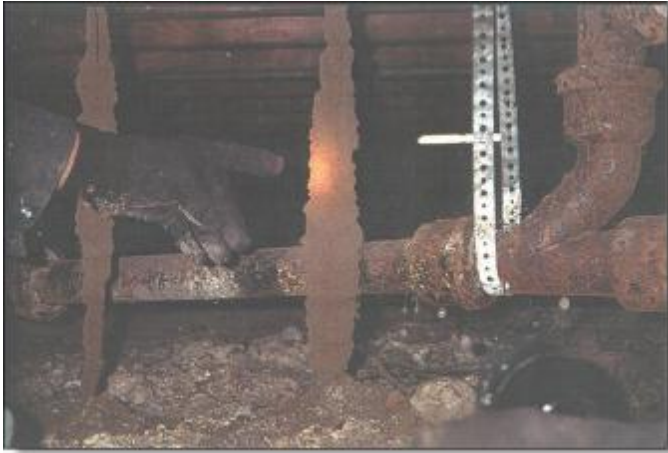
# 1

**FINDING:** Possible hidden termite damage at area indicated.

**RECOMMENDATION:** Owner/Agent should engage services of a licensed contractor to remove visible surface fungus and loose stucco. The area(s) currently concealed will be inspected for a fee if made accessible by the owner/agent at his/her expense. A supplemental report will be filed at such time. No opinion is rendered concerning the condition at this time. Owner/Agent responsible for replacing stucco with new material.
