WOOD-DESTROYING PESTS INSPECTION REPORT

No **30176**

Firm (PCO) ABC Pest Group License No. 456-33432-3 Inspection Date 2/28/2008
 Address 12234 Crestwood Dr. FHA/VA/Escrow or Mortgage No. 123456789101112131415
 Address of Property Inspected 76 Tortoise Way Las Vegas 87905 Clark
 City Zip County
 Inspection Ordered by John Borwn's Realty, 1220 Cactus Lane, Las Vegas, NV 89709
 Inspection Report Sent to Tom's Title & Mortgage, 520 Ivy Way, Las Vegas, NV 89709
 Owner's Name and Address Mr. Edward Smith, 76 Tortoise Way, Las Vegas, NV, 89709

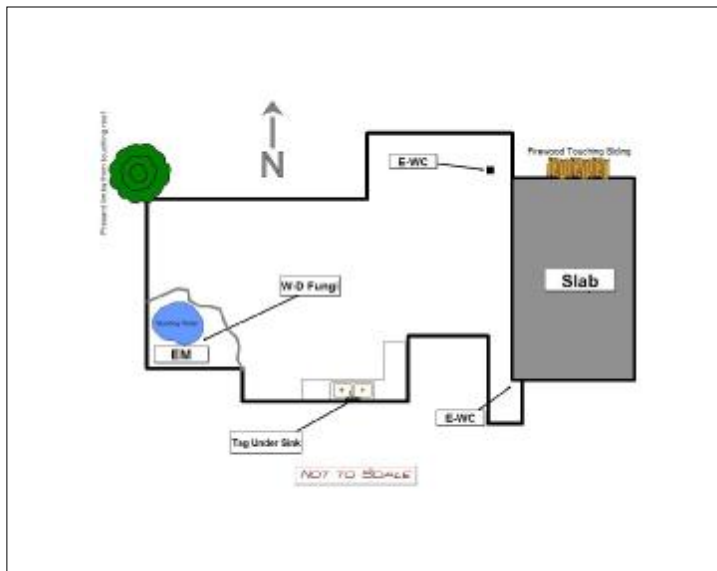
INFESTATION: (See diagram and explanation below.)

E-WC: Earth-wood contact between soil and pier post. Recommend pier block under pier post.

EM: Excessive moisture, due to leaking water pipe under kitchen. Recommend plumbing repairs as soon as possible.

W-D Fungi: Active wood-destroying fungi on subflooring. Recommend fungicide treatment

FG: Faulty grading between entry way and garage. Recommend lowering soil level in planter 3" below top of foundation.

Remove firewood from touching siding. Make sure limbs of tree do not touch roof in the future.
